NWC TP 4738

# SAFETY TESTS OF EXPLOSIVES TRANSPORT TRUCKS

## NAVAL WEAPONS CENTER

CHINA LAKE, CALIFORNIA \* JULY 1969

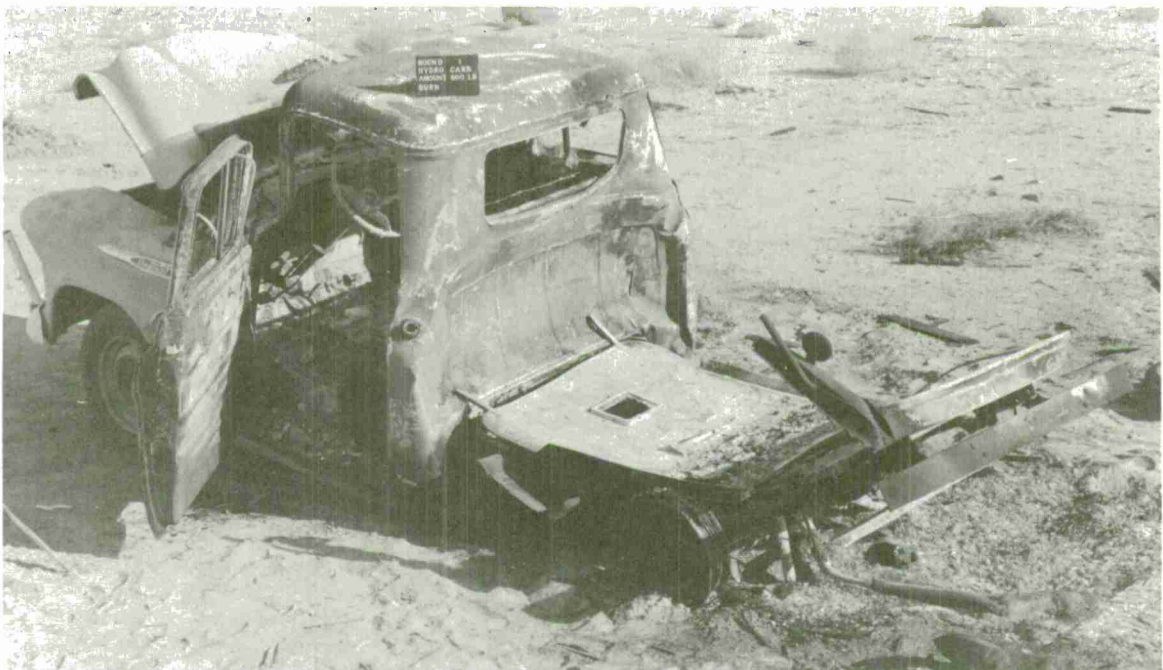
After propellant ignition, burning continued for 2 to 3 seconds, after which time an explosion or low-order detonation occurred. Propellant was scattered over a wide area, up to 298 feet from the truck. Much of the propellant did not burn. The bed of the truck was destroyed, pieces of it being thrown as far as 234 feet. The steel shield was blown against the back of the cab and then slid down onto the bed of the truck (Fig. 3). Figure 4 shows that the inside of the cab was completely gutted by fire and that the mannequin was destroyed. The thermocouple attached to the face of the mannequin indicated a temperature rise to  $520^{\circ}\text{F}$  in 4 seconds and then failed mechanically. The thermocouple attached to the hand recorded nearly as rapid a rise to  $300^{\circ}\text{F}$ , a slight dip, and then a rise to  $410^{\circ}\text{F}$  about 10 seconds after the start of the test. The thermocouple on the seat beside the mannequin reached  $130^{\circ}\text{F}$  in 4 seconds and then decayed slowly.

The right rear wheel of the truck was blown off; the left rear wheel burned on the truck; but the front wheels and tires were not damaged. There was little evidence of fire in the engine compartment or front of the truck even though the hood was blown open by the blast.

FIG. 3. Truck Damage From Burning and Subsequent Explosion of 600 Pounds of Propellant, Test 1.

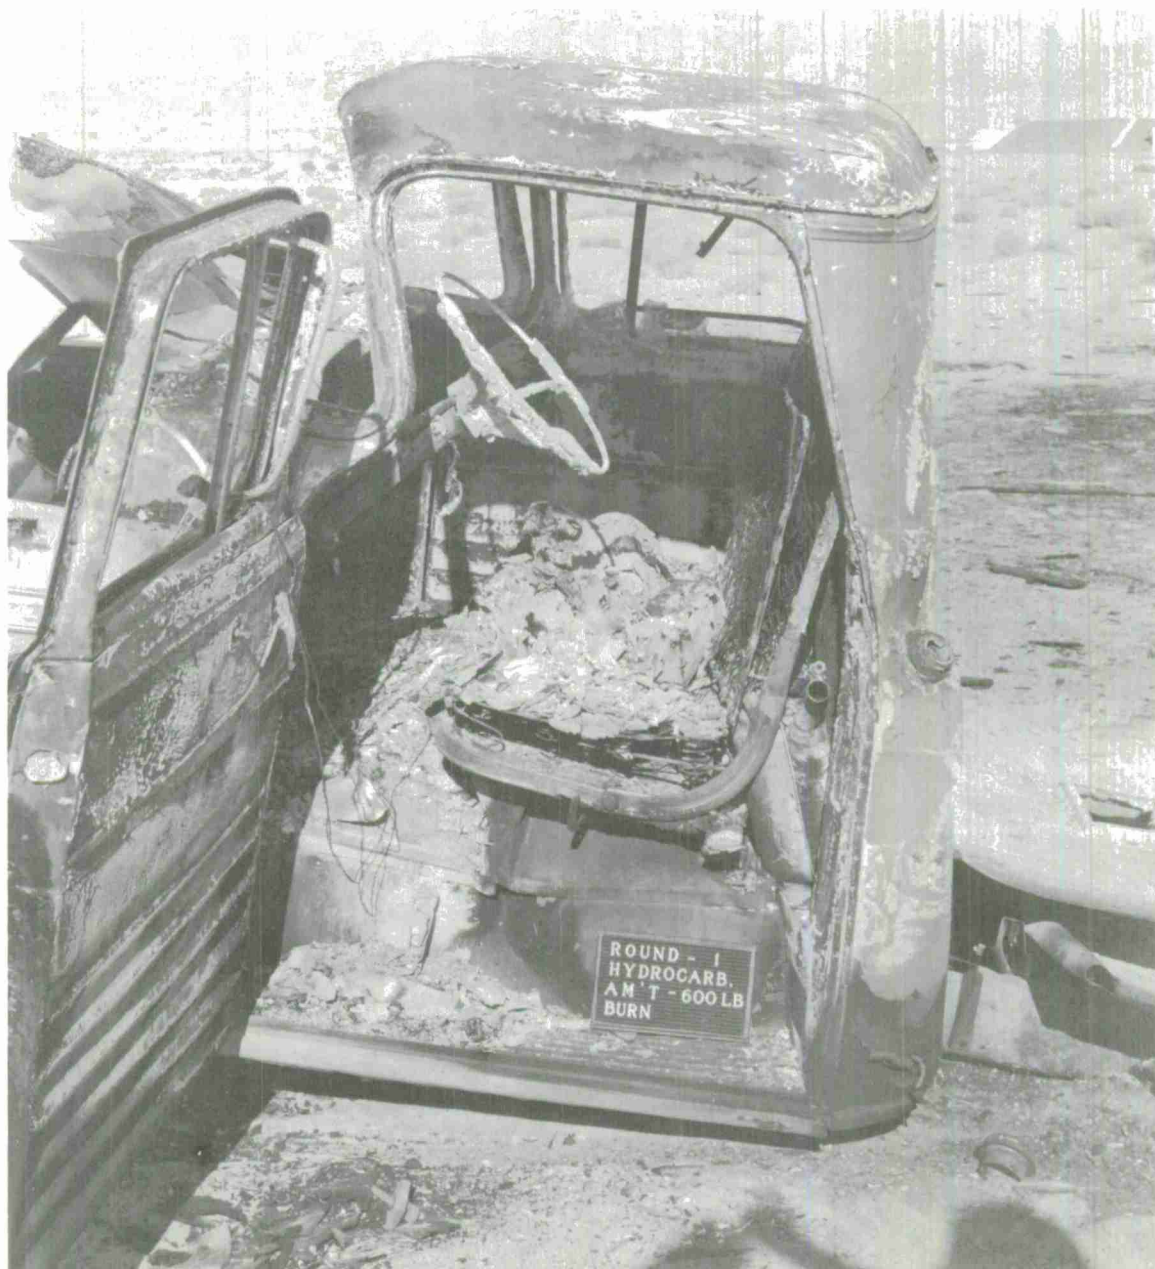
FIG. 4. Destruction of Mannequin and Cab Interior, Test 1.

It is doubtful that persons in the cab could have escaped without rather severe burns. Since only a burning test was desired, there was no measurement of blast pressure. This test, however, gave good evidence that we cannot expect hazardous materials to react in accordance with our plans. The unplanned reaction was due either to too strong ignition or too great confinement of the propellant.

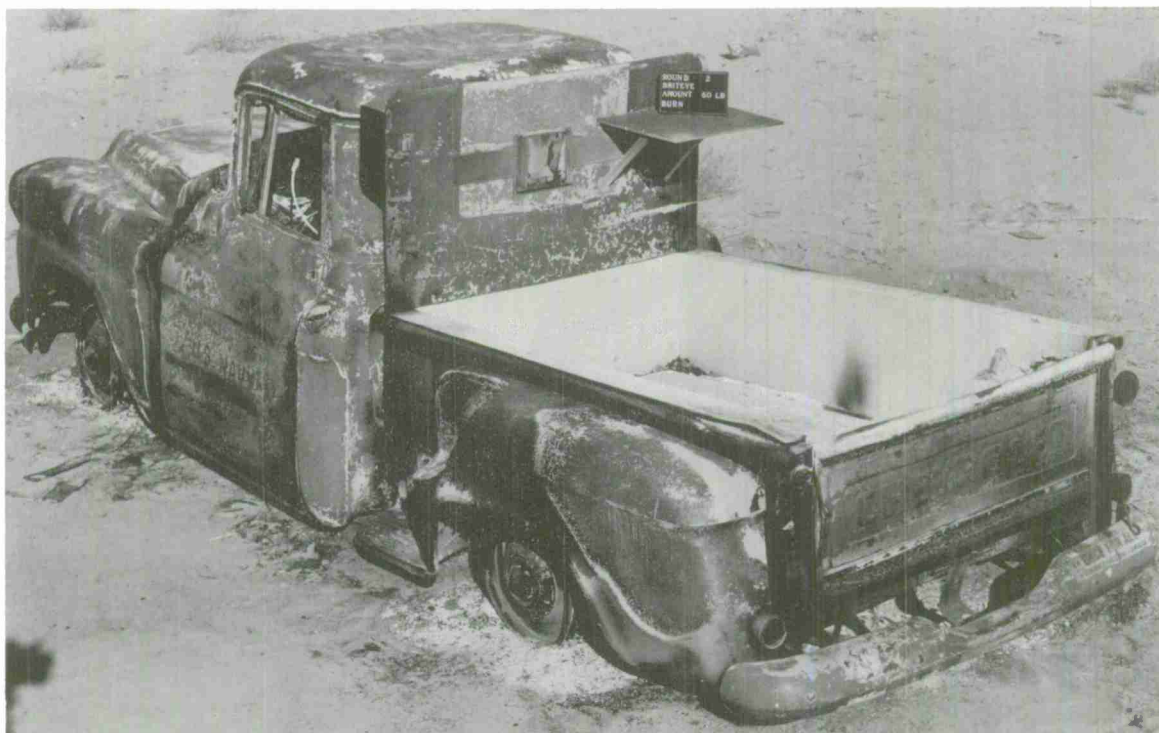
The flare burned for about 5 minutes. It burned through the aluminum truck bed, but there was little evidence of the burning of any other materials (Fig. 6 and 7). The steel shield appeared to be undamaged. The truck was observed on the TV monitors for about 15 minutes after the flare stopped burning, and, since there was no further evidence of burning, all test personnel left the area for lunch. A short time later (estimated to be less than 15 minutes), the residual heat again ignited combustible materials of the truck, including the cab interior, engine compartment, and tires. The truck had completely burned when personnel returned to the area about 1 1/2 hours later (Fig. 8). The three thermocouples in the cab did not show any temperature rise during the time the flare was burning.

FIG. 6. Truck After Burning, Test 2.

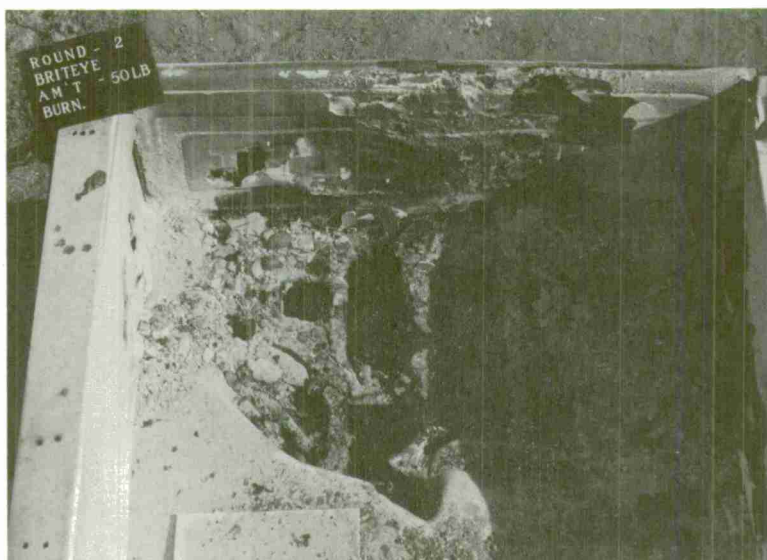
FIG. 7. Damage to Truck Bed, Test 2.

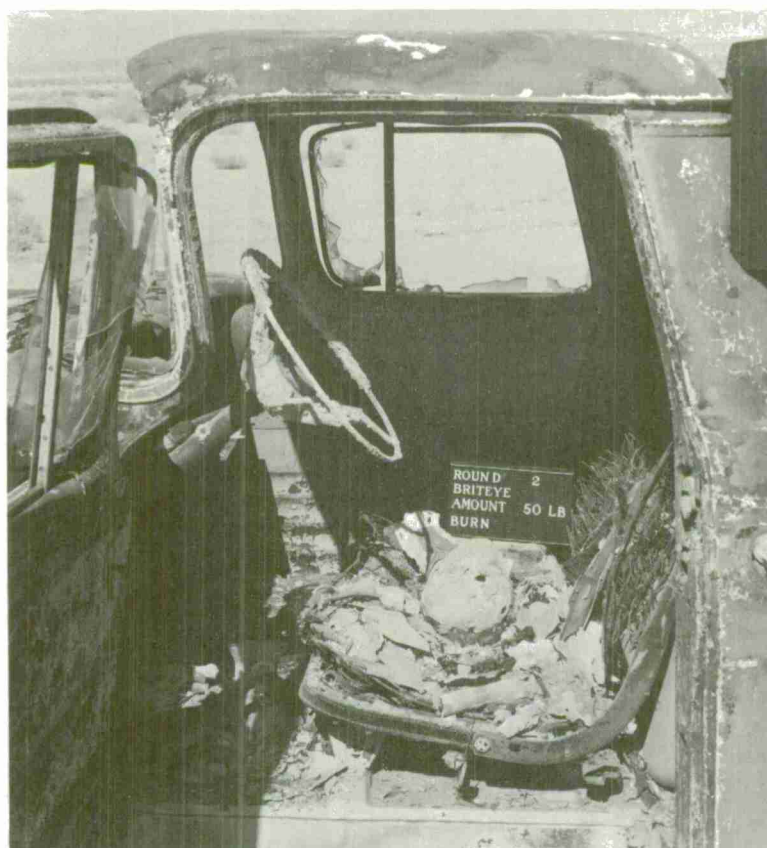
FIG. 8. Destruction Resulting From Reignition Caused by Residual Heat of Combustible Material, Test 2.

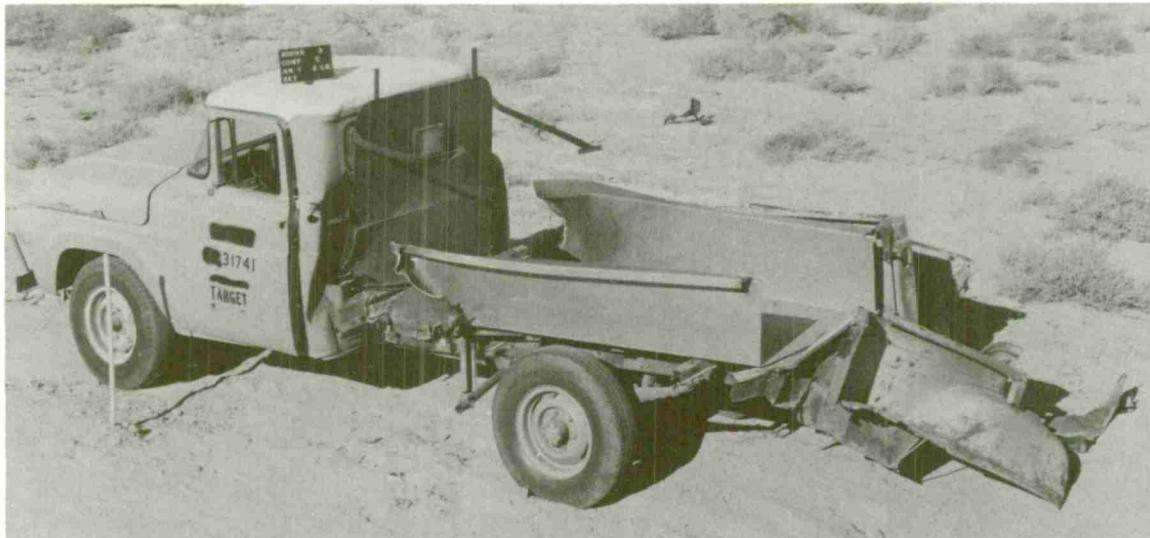
Detonation was high order and complete. The whole left side of the truck bed was torn loose and peeled back from the bed (Fig. 10). The rear of the right side was pulled back to the fender area. The tail gate was torn loose and blown back 68 feet beyond the rear of the truck. Other pieces of the truck metal were blown as far as 70 feet from the truck. The lower corner of the steel shield was pushed into the cab below the driver's seat with sufficient energy to tear a hole in the metal of the cab (Fig. 11). Figure 11 also shows that the welded aluminum bed was torn and pulled back at the front corners. A 32-in<sup>2</sup> hole was blown through the bed of the truck in the place where the Composition C-3 block had been.

FIG. 10. View of Truck After Detonation, Test 3.

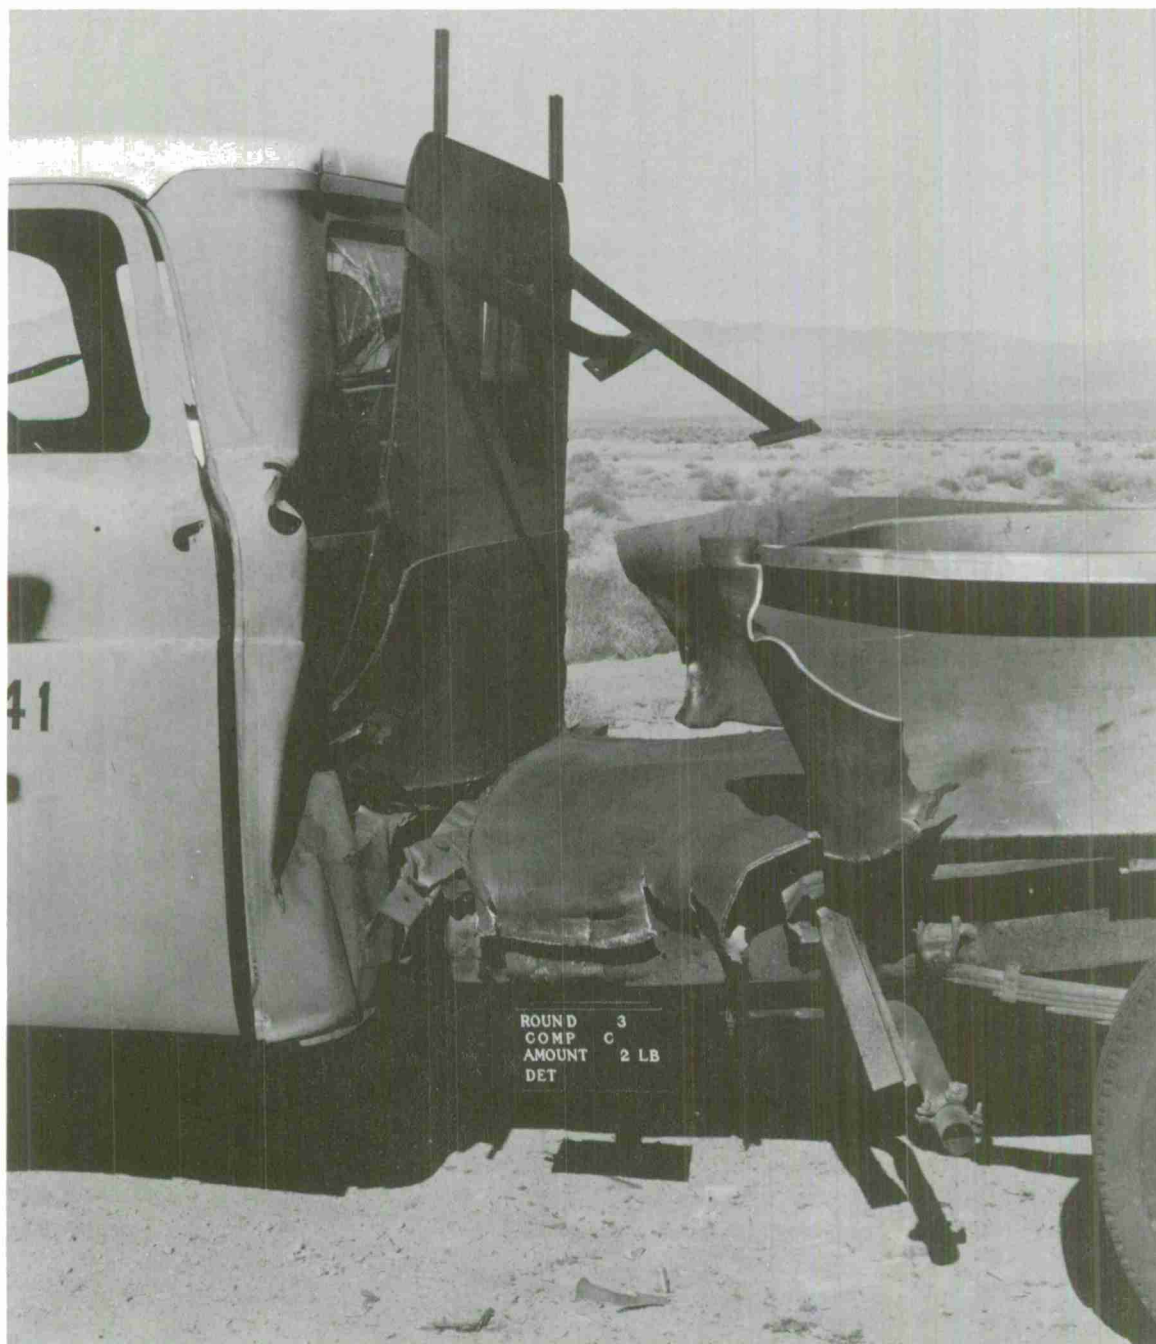
FIG. 11. Closeup of Damage Resulting From Test 3.

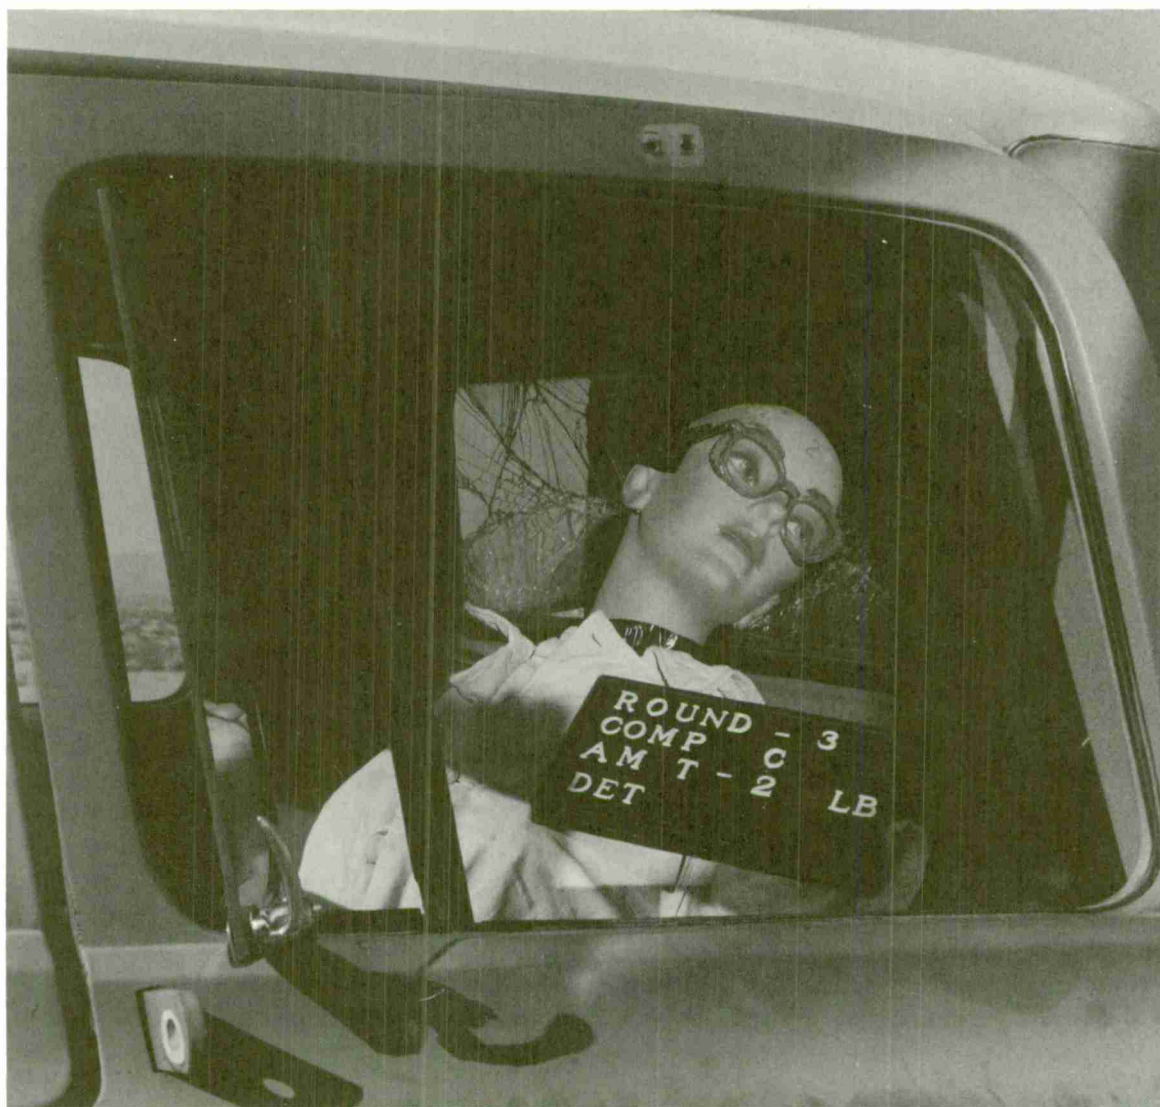
Although the pressure transducers did not show any rise in pressure, there was evidence of pressure rise within the cab. Figure 12 shows the window in the rear of the cab pushed outward and severely cracked. It was still in place but was torn loose from the bottom mounting. The windshield was cracked, and the frame was pulled loose. The mannequin had been thrown against the steering column, and the hard hat had been torn loose from the headband that was still on the mannequin. The roof of the cab showed evidence of being pushed up slightly and had buckled at the right front corner.

FIG. 12. Mannequin and Cracked Rear Window of Cab, Test 3.

There is no doubt that personnel in the cab would have sustained some injury caused by displacement in position. Although the transducer showed no pressure, there was indication of pressure in the cab that might have caused ear damage or at least discomfort.

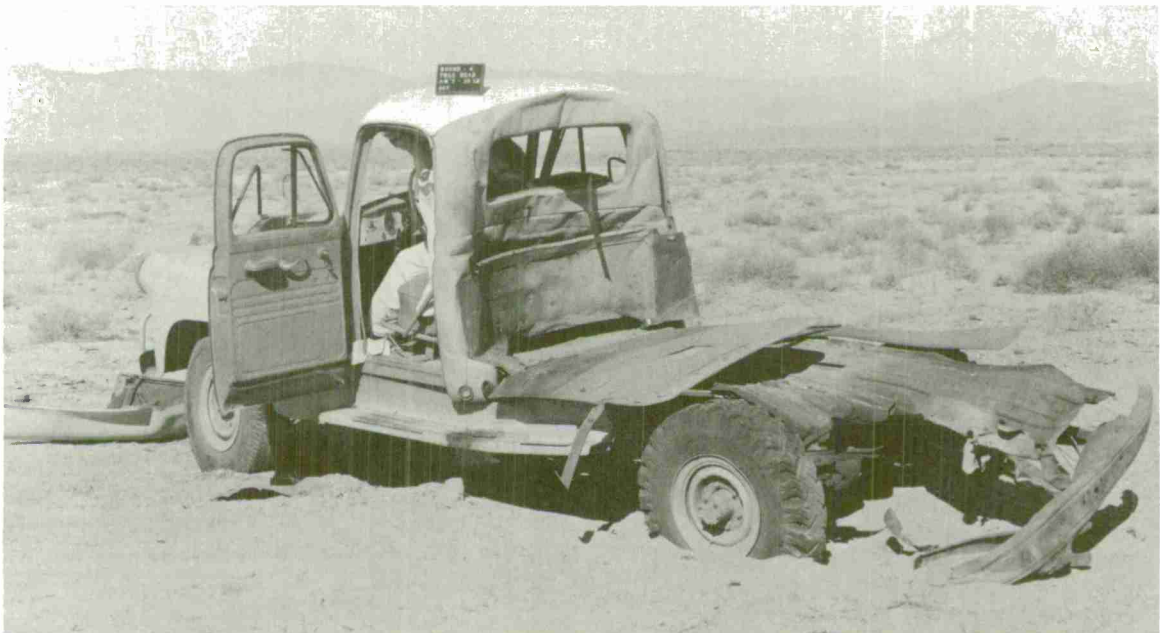
The truck bed was completely blown from the truck, and both rear wheels and tires were severely damaged. The steel barrier shield was torn loose and pushed into the back of the truck cab, forcing the mannequin against the steering column with sufficient force to break the steering column (Fig. 14 and 15). The back of the seat was blown partially through the windshield, which was almost completely blown out. The cap was blown off the gas tank, and the tank was punctured near the top. There was also evidence that some gas had spilled out and burned on the ground beside the truck. No other evidence of burning was apparent in this test. The hood of the truck was blown off. Pieces of the truck metal were blown to a distance of 262 feet from the truck (Fig. 16).

FIG. 14. Damage Resulting From Detonation, Test 4.

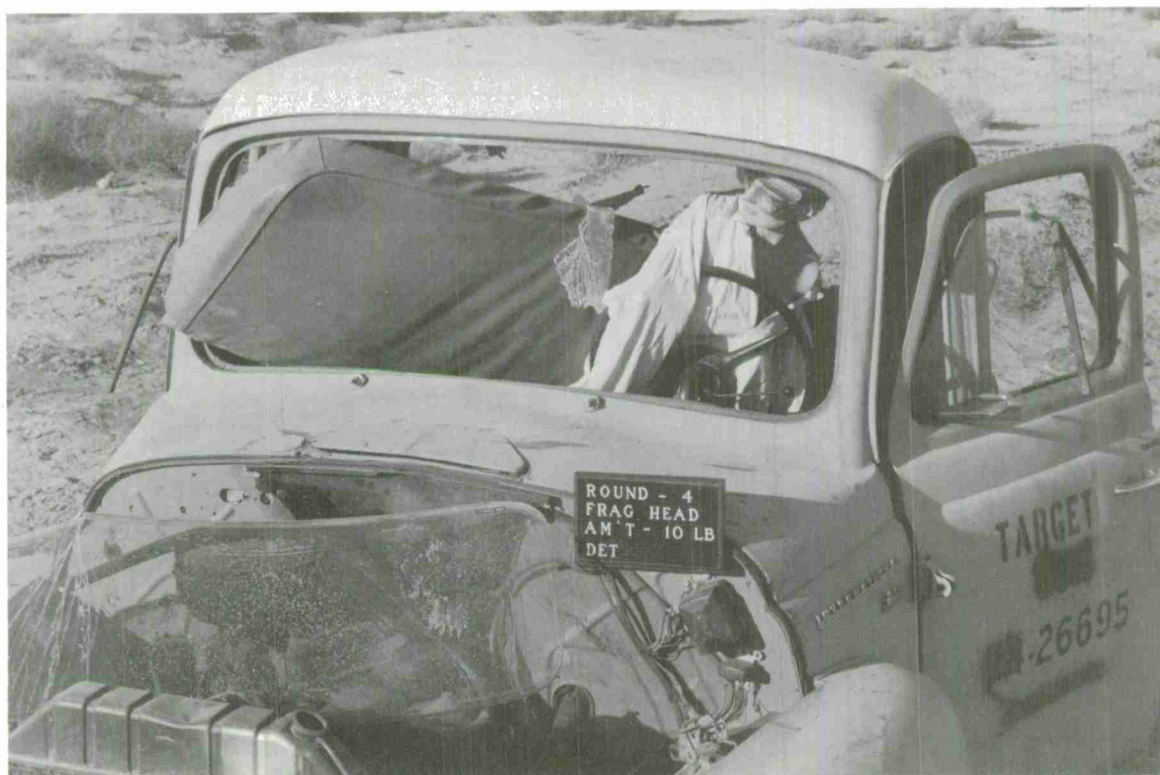
FIG. 15. Cab of Truck After Test 4.

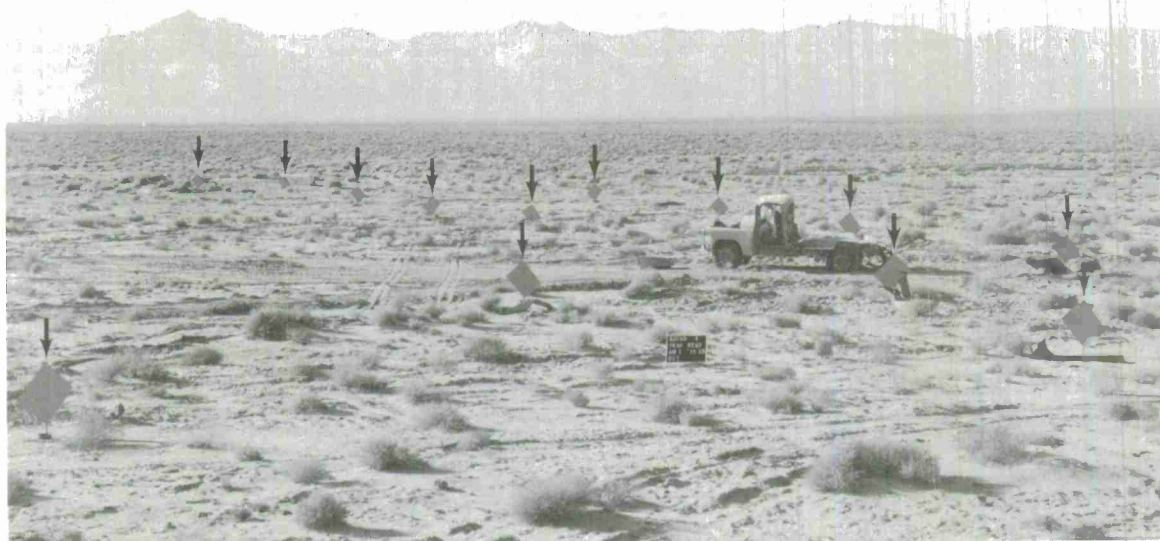
FIG. 16. Dispersion of Truck Fragments (Arrows), Test 4.

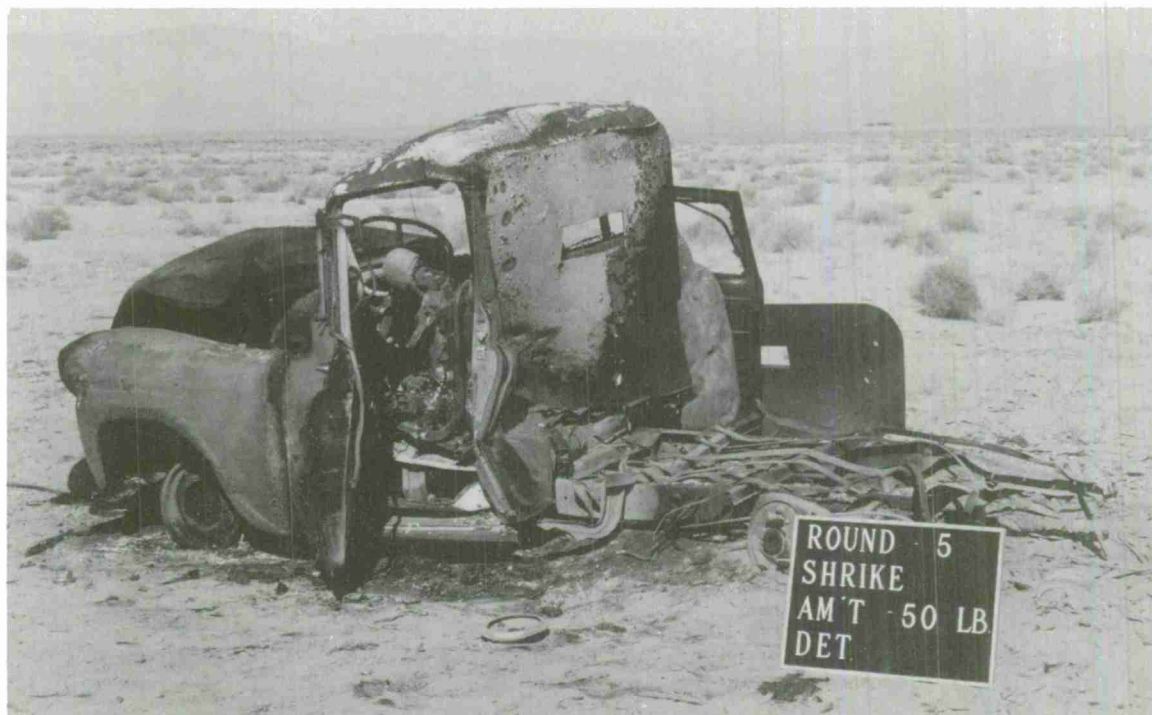
All of the truck aft of the cab was completely blown apart (Fig. 18), and pieces were blown to a distance of 681 feet from the test location. The remainder of the truck and the anthropomorphic dummy used in this test were completely burned by the fire resulting from the blast (Fig. 19).

FIG. 18. Condition of Truck After Detonation of 50 Pounds of PBXC-104 Explosive, Test 5.

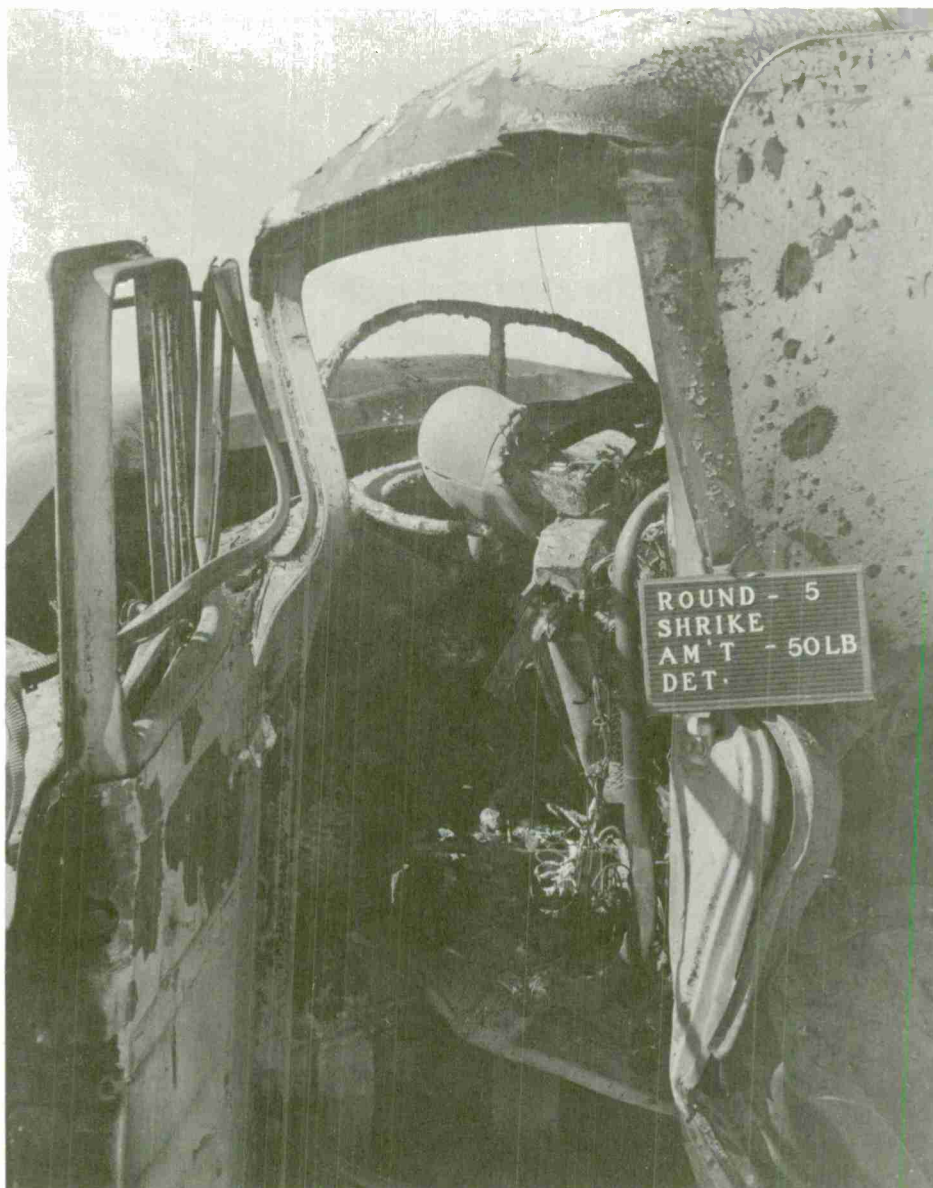
FIG. 19. Damage to Cab and Dummy, Test 5.

Personnel in or adjacent to the truck would have been fatally injured.
